PROTECTION OF AIRCRAFT FLUID SYSTEMS

LTV Aerospace Corporation

TECHNICAL REPORT AFML-TR-68-125

May 1968

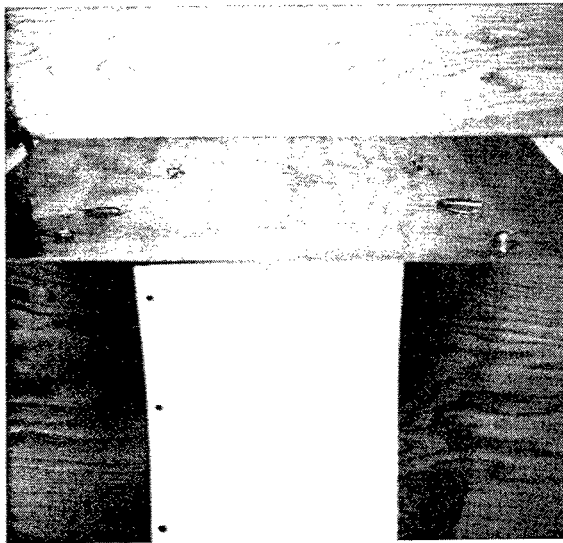
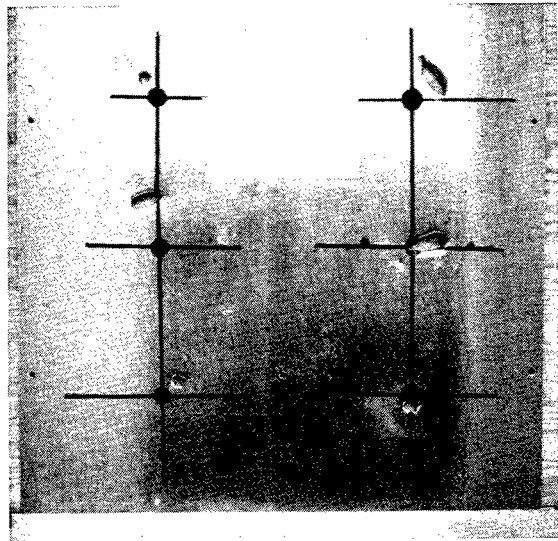
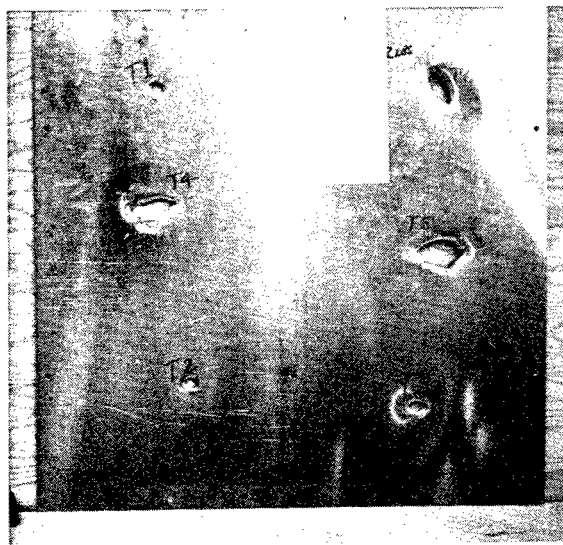
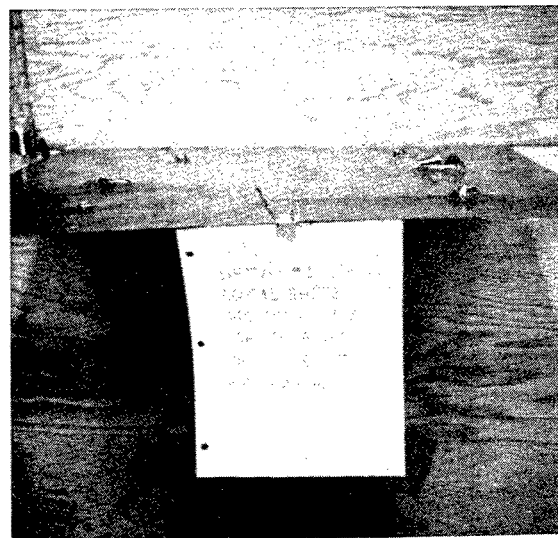
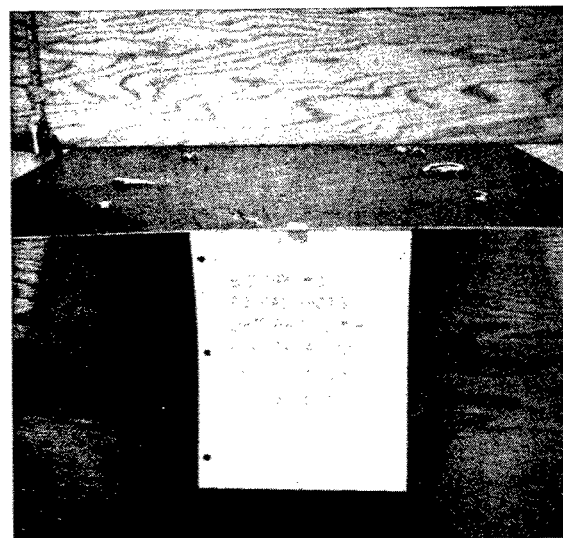
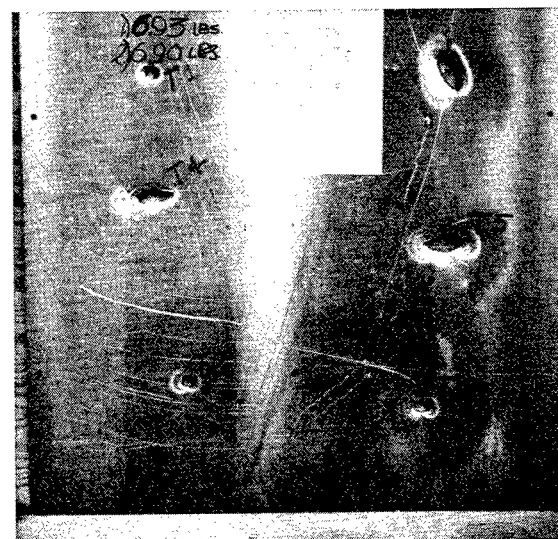
Figure F-1 CALIBER .50 SHOTS, 6061-T6 ALUMINUM

Figures F-1 through F-8 of Appendix F show photographs of all skins tested and Tables G-I through G-VIII of Appendix G show the measured detail size and comments on type of damage incurred by the panels. Round numbers T1 through T59, shown in the photographs, correspond to the round numbers listed in the tables of Appendix G. The effect of any one particular round can be traced through all three panels by the round number shown in the photograph and the correlating tabulated measurements and comments. For added convenience, the tables are cross-referenced to the photographic figure of the gunfired panel. Most of the photographs are views of the entrance and exit sides of the test panel. Some edge shots are included to show petal height and petal roll.

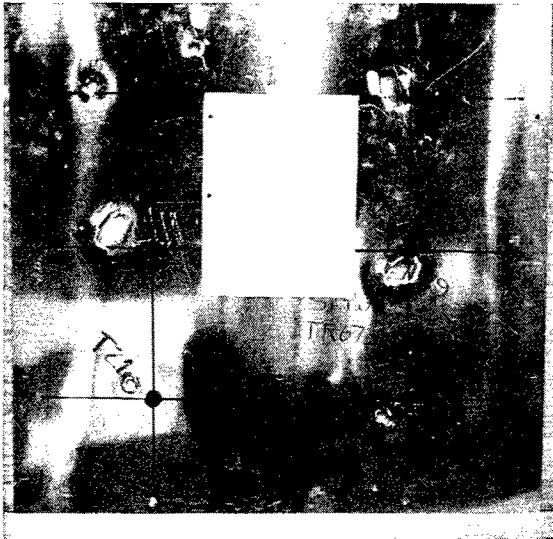
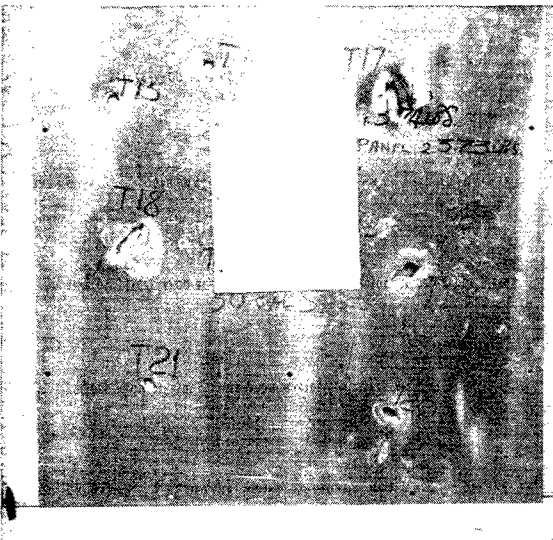
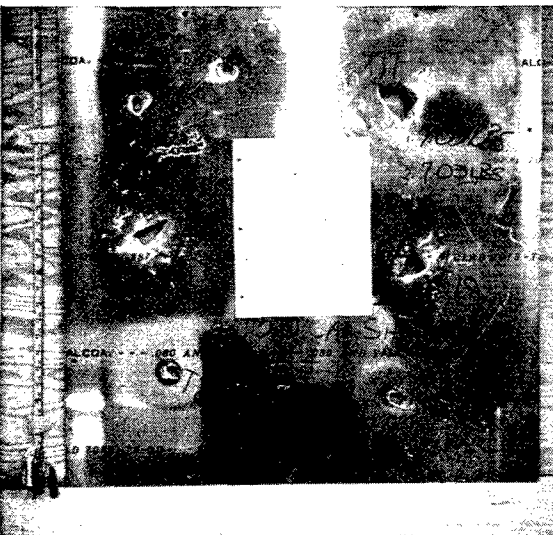
Figure F-3 Caliber .50 Shots, 7075-T6 Clad Aluminum

Rounds T17 and T18, shown in Figures F-3(a), (c) and (e), are examples of coring. Normally, shrapnel damage and burning of second and third skins will occur when all three skins are cored. Round T18 in Figure F-3(c) and (e) shows coring and shrapnel damage very clearly, but on the same figures, Round T17, which also cored, shows very few shrapnel marks. The burning that sometimes accompanies coring and shrapnel damage is not well defined in the photographs; however, its presence can be detected by the panel discoloration (darker) in the area of the projectile hole such as that shown by T26 in Figure F-4(c) and very well in Figure F-4(e). Some fireflashes and fireballs were observed during caliber .50 AP gunfiring with some being recorded on film. These were observed more on the 7075-T6 and AMS 4901 titanium panels than on the other alloys. During the caliber .30 firing, the flashes and fireballs were noticed only when the titanium skins were shot. These fire flashes appeared to accompany the tumbled rounds more than the

straight-through shots. In some instances, the second and third skins showed unmistakable evidence of the presence of fireballs in that the front surface showed discoloration from heat and shrapnel damage from the first and second skins in the stack. There are additional descriptive notes listed at the bottom of the tables of Appendix G which further describe the damage to the skin panels.

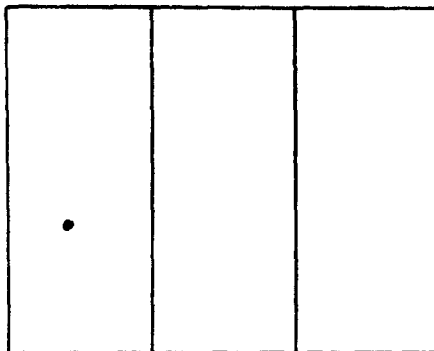
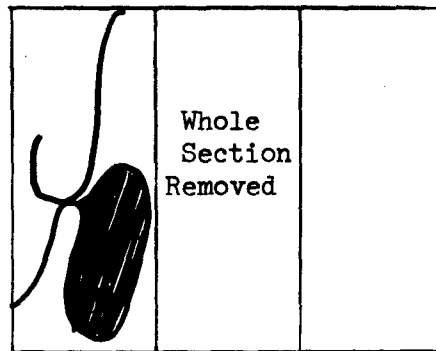
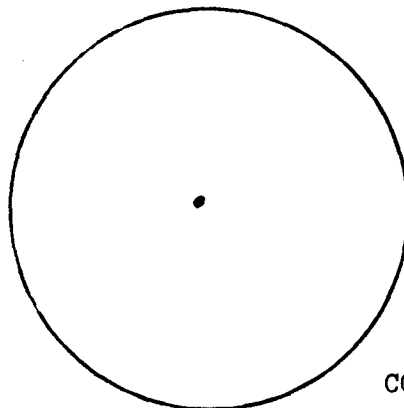
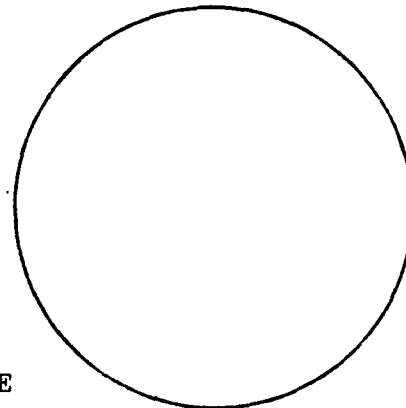
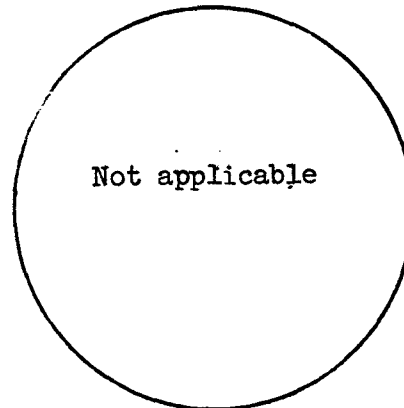
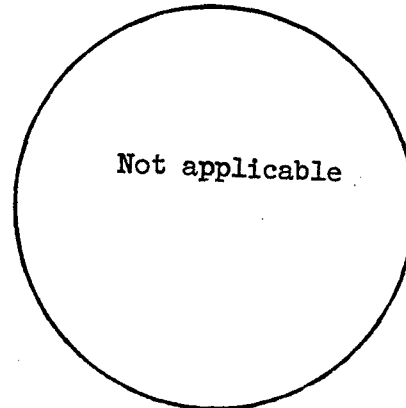
BLOCK NUMBER B 12  
ROUND NUMBER T 1

The composite material failed with a piece of material approximately 12 in x 4 in. coring out. Rest of the Panel was split.

No projectile marks were found on the material, thus indicating that the panel was failed by the pressure wave in front of the projectile. All the fuel (55 gal.) was lost.

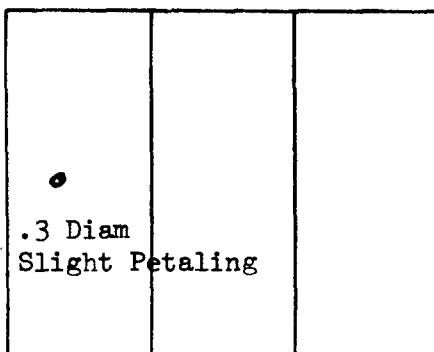
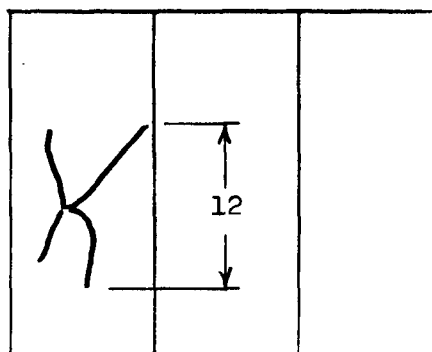
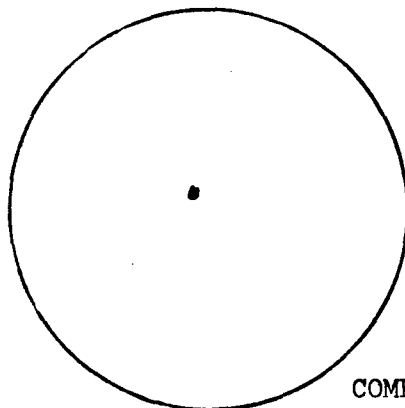
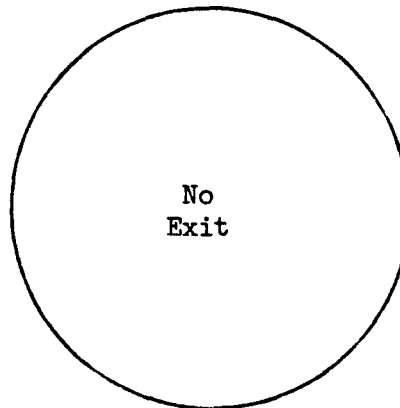
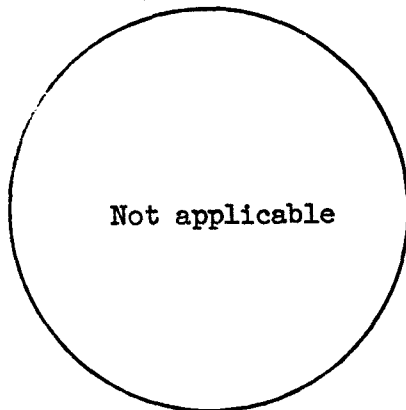
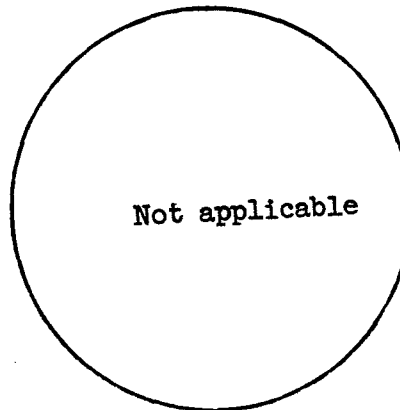
ROUND NUMBER T 2

The self-sealing was not damaged. The skin was cracked badly.

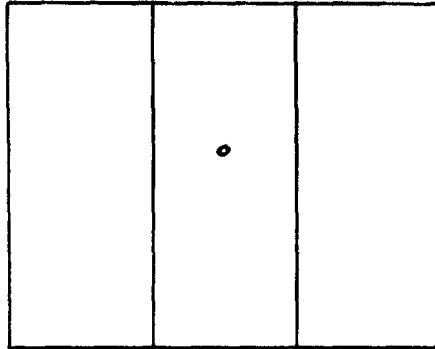
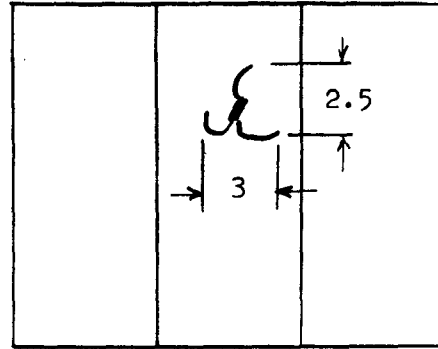
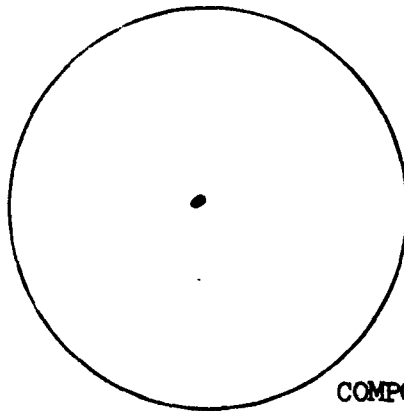
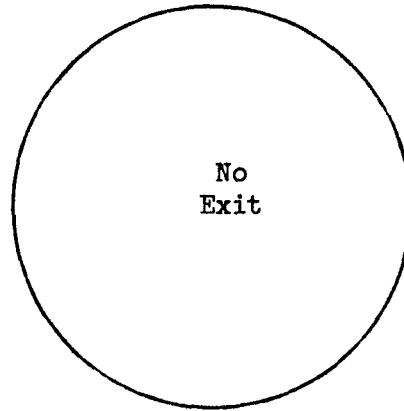
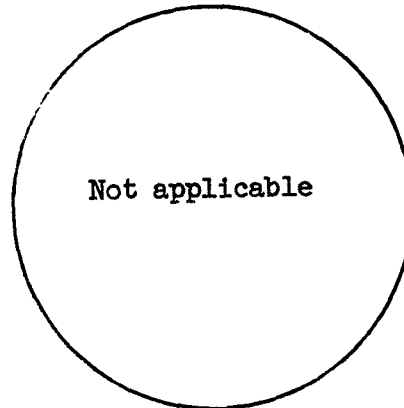
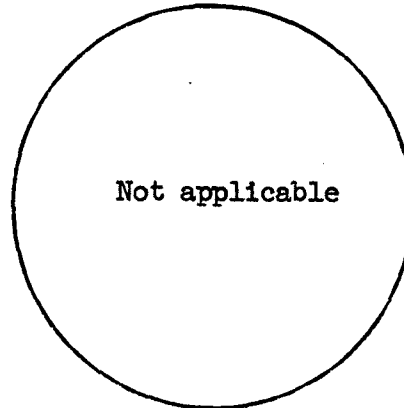
ROUND NUMBER T 3

The sealing material suffered no damage. The skin was cracked but not penetrated. No leakage occurred.

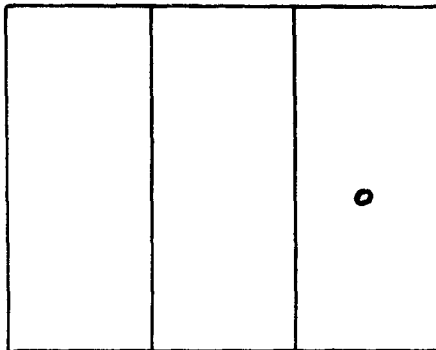
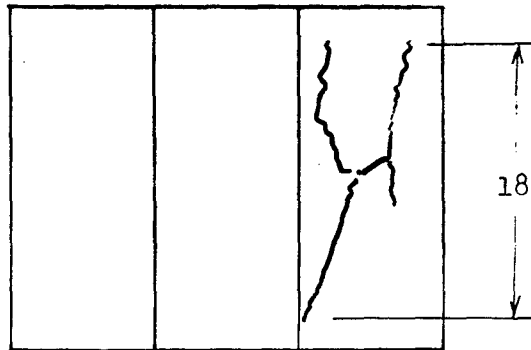
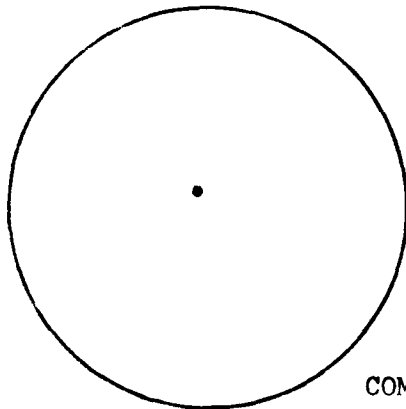
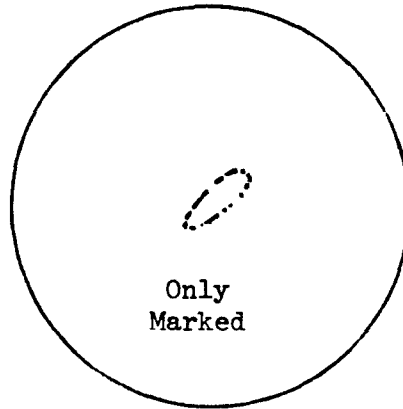
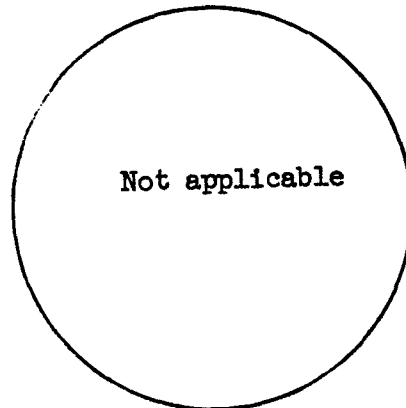
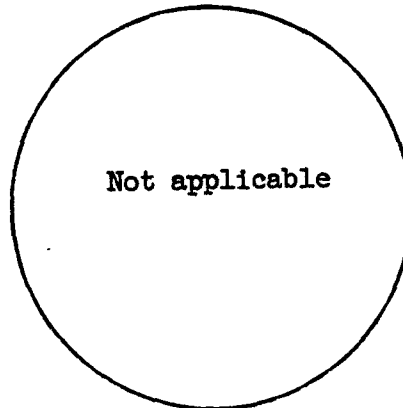
ROUND NUMBER T 4

The Skin was badly cracked. The self-sealing was marked but not damaged .  
No leakage.

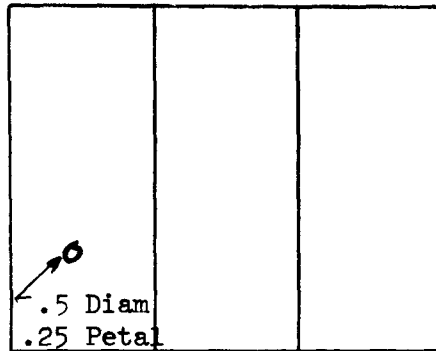
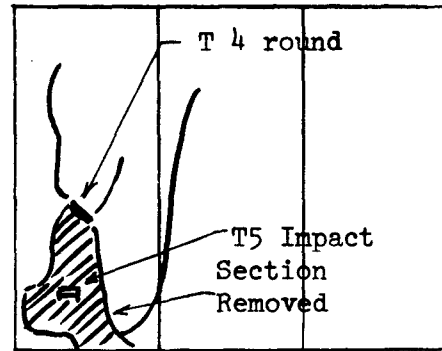
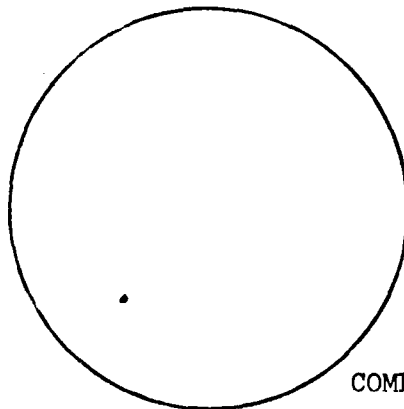
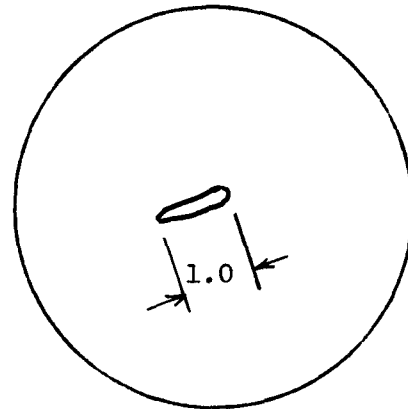
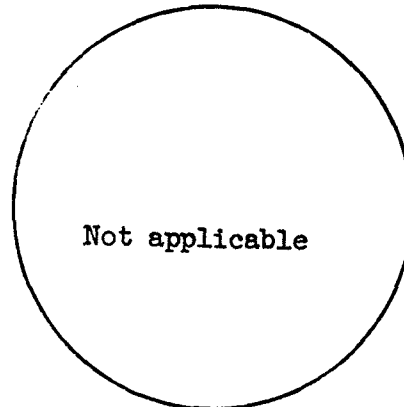
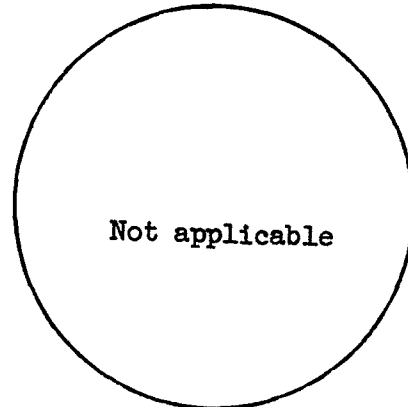
ROUND NUMBER T 5

The skin was broken up badly with a large portion knocked out between wounds of T4 and T5.

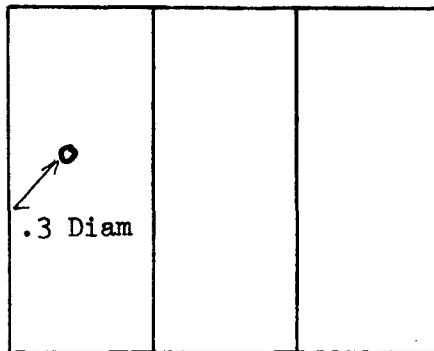
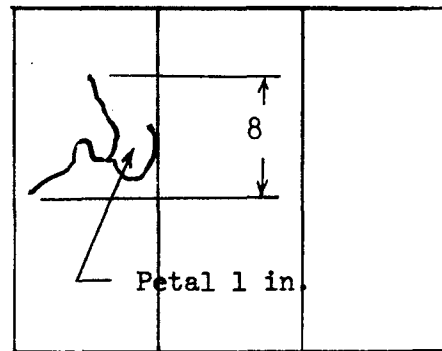
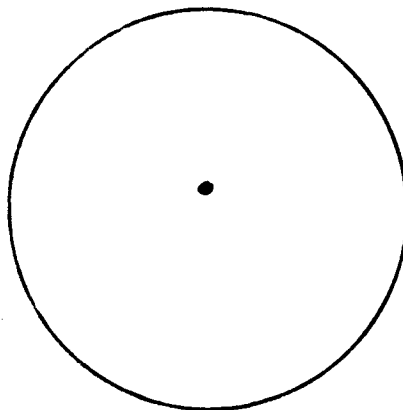
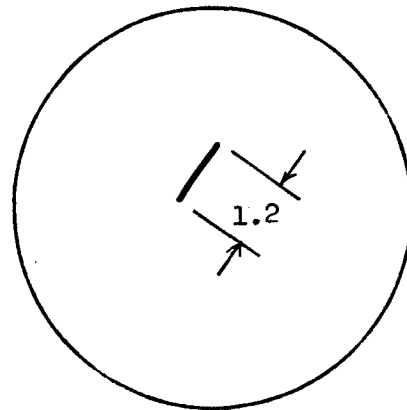
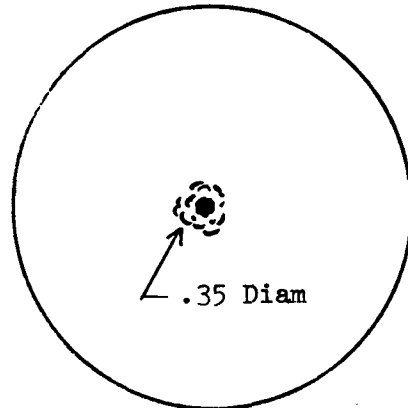
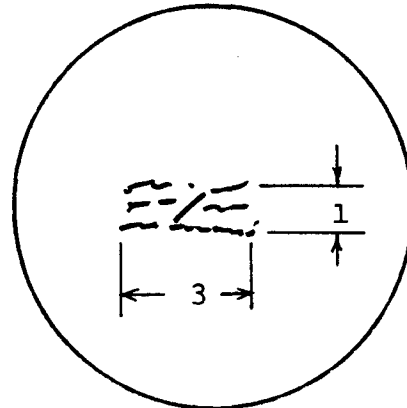
ROUND NUMBER T 6

The backing board was frayed. The self sealing material sealed with no leakage.

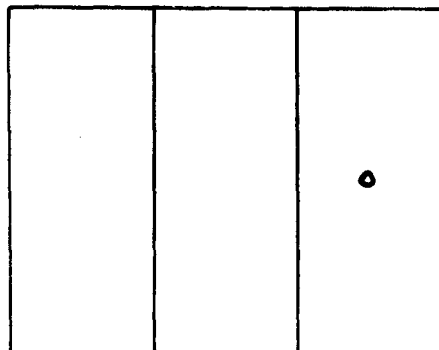
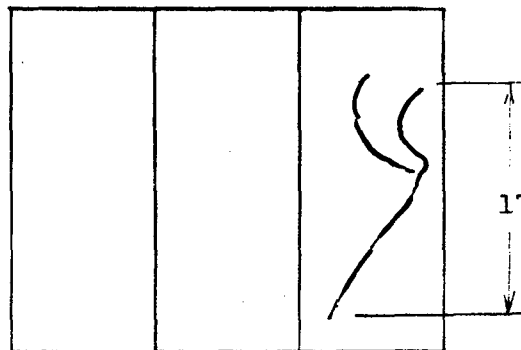
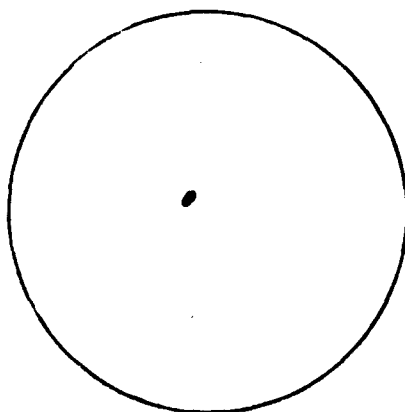
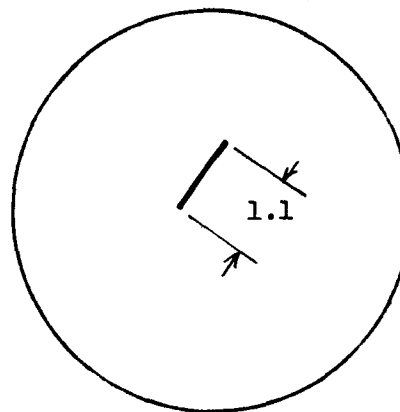
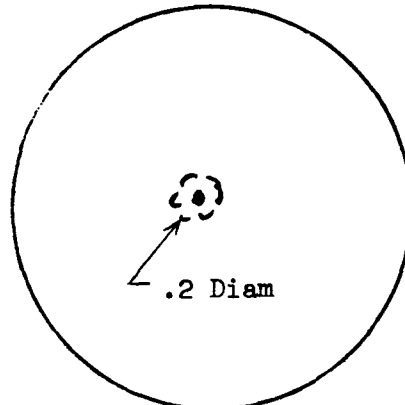
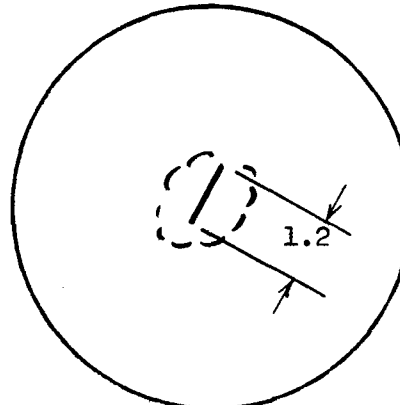
BLOCK NUMBER B 8  
ROUND NUMBER T 7

The skin was cored and petaled .25 inches high. The backing board was cored the size of the tumbled round. The self-sealing material seeped for 1 minute before obtaining a damp seal. The leakage was not measurable.

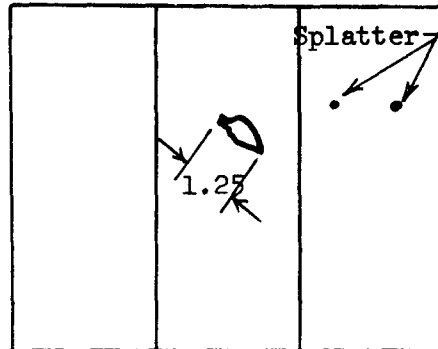
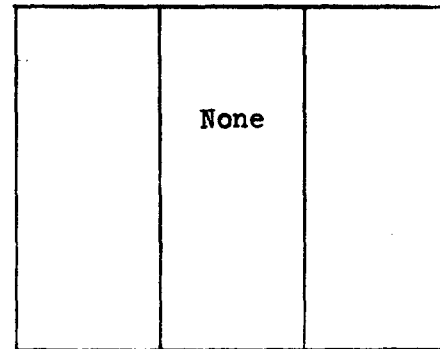
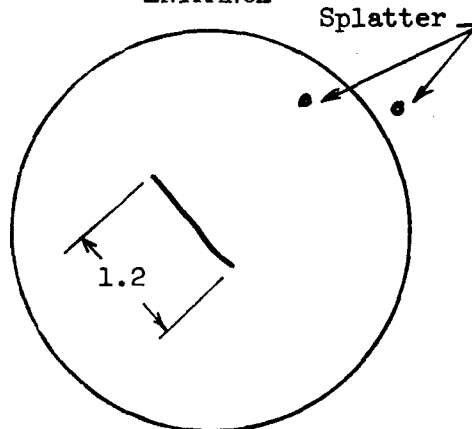
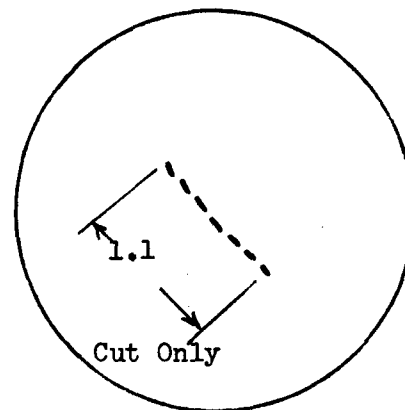
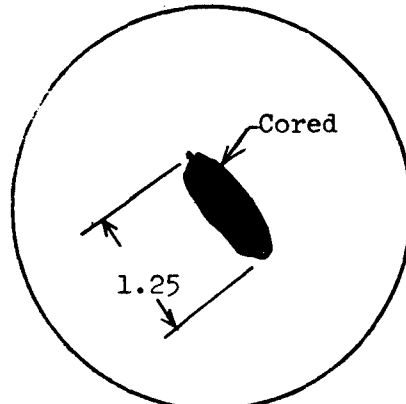
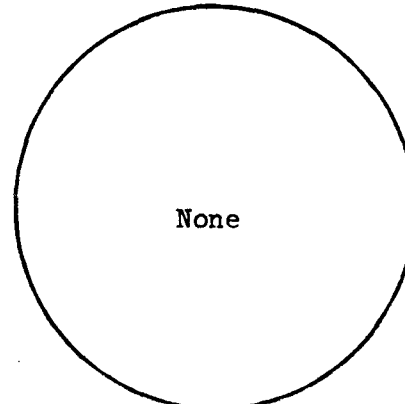
ROUND NUMBER T 8

Entrance: About one-half tumbled 9.5 inches below the fuel surface.  
The skin was cored full size of the hole and deflected about .25 inches.  
The backing board was frayed. The self-sealing material sealed immediately with only a trace of fuel leakage.

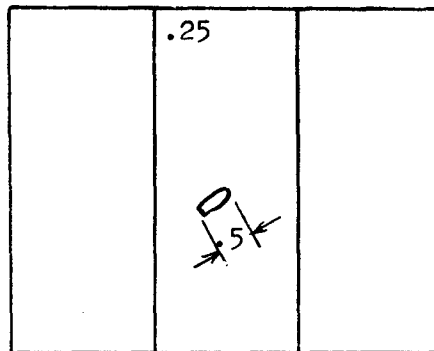
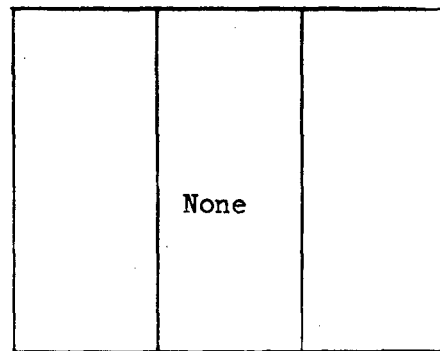
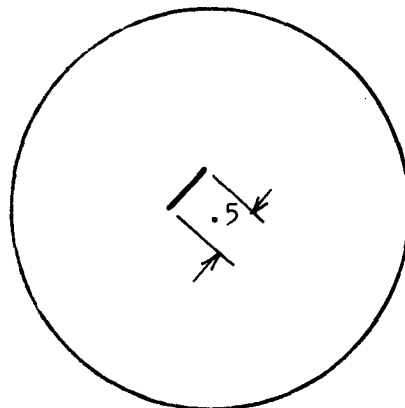
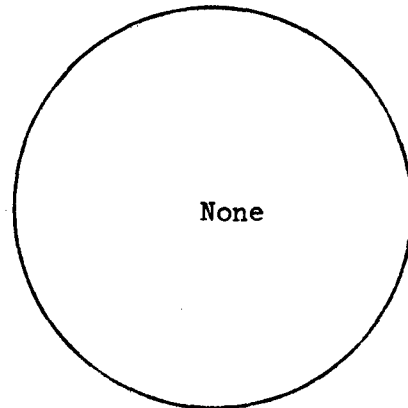
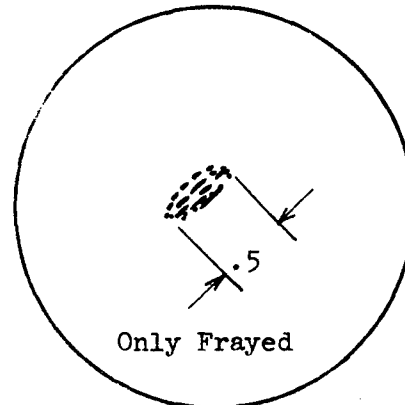
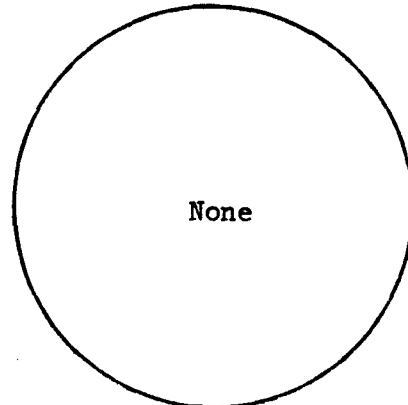
BLOCK NUMBER B 8  
ROUND NUMBER T 9

The skin was cored and cracked slightly. The backing board was just frayed. The self-sealing material sealed immediately with no leakage.

The skin was failed totally with a section 7.5 inches wide and 24 inches long removed in several pieces. The crack from round T 7 spread out to edge of the panel. The backing board was frayed and buckled 2 1/2 inches high. The self-sealing material was cored slightly and was not supported by the backing board. Cavity leaked approximately 38 - 40 gallons in 2 minutes.

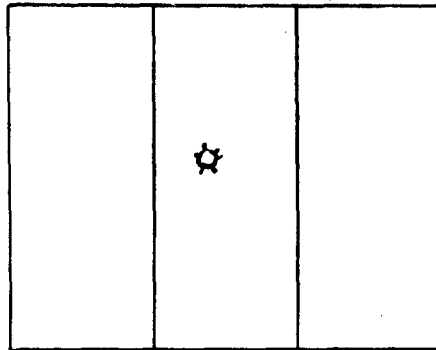
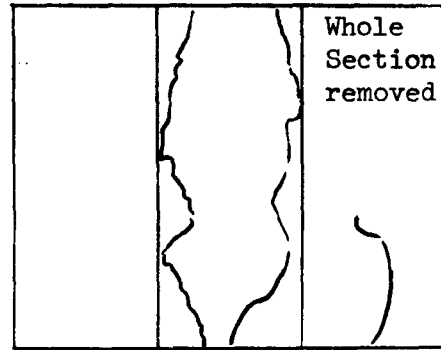
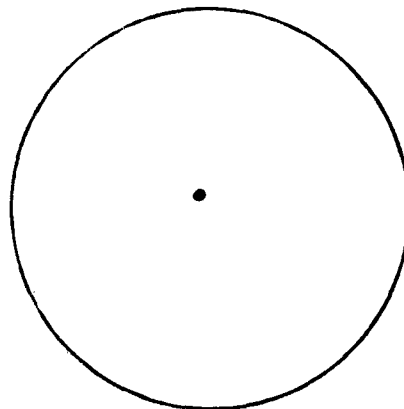
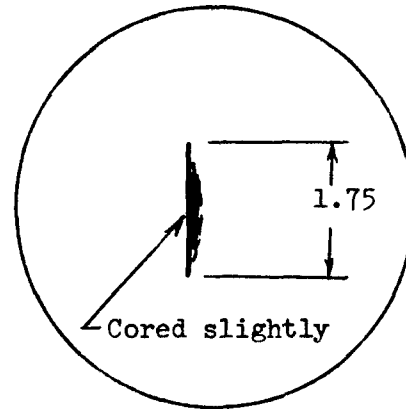
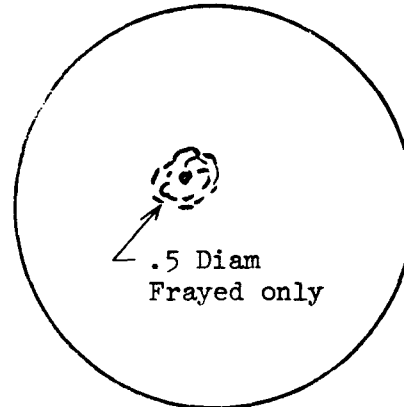
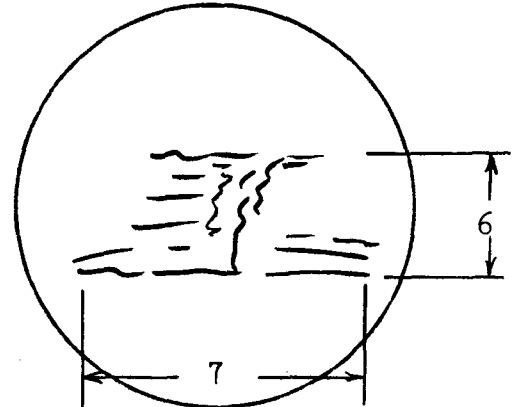
ROUND NUMBER T 10

Spread  
of T7  
damage

Observers saw a flash on the entrance skin. The skin was cored. The backing board was frayed. The self-sealing material sealed immediately with no leakage.

The skin was cored. The backing board was cored. The self-sealing material was cored slightly. It was a reduced rate type leakage. Flanges let go so could not establish a rate.

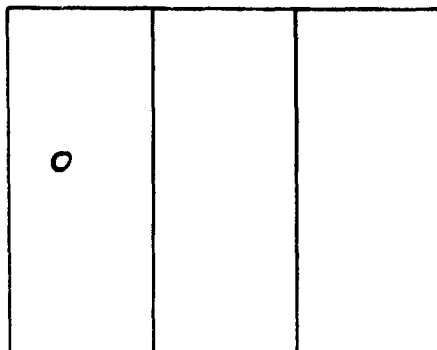
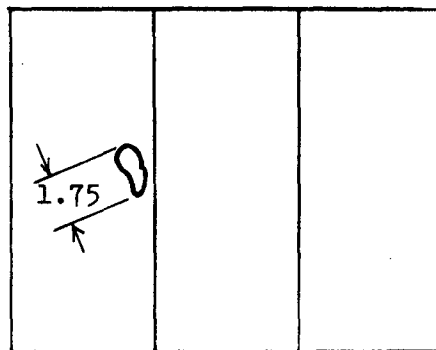
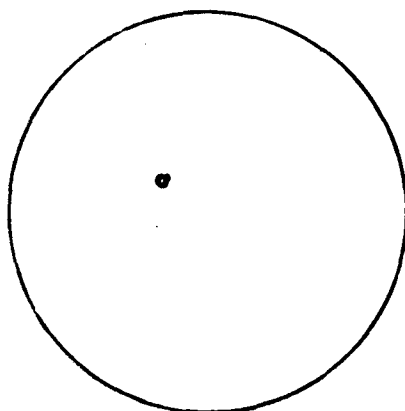
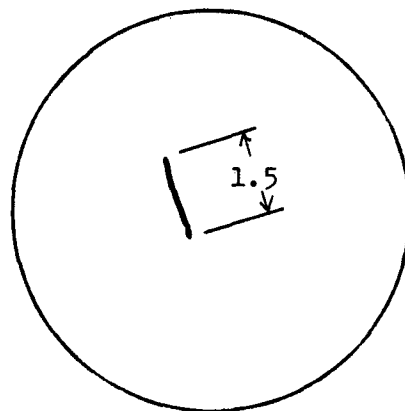
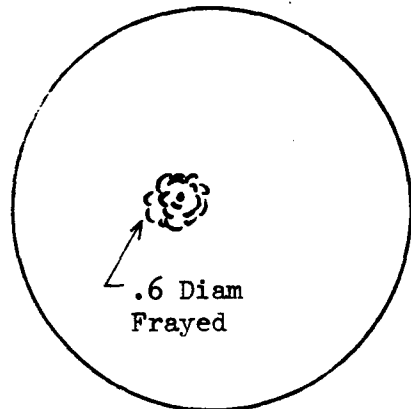
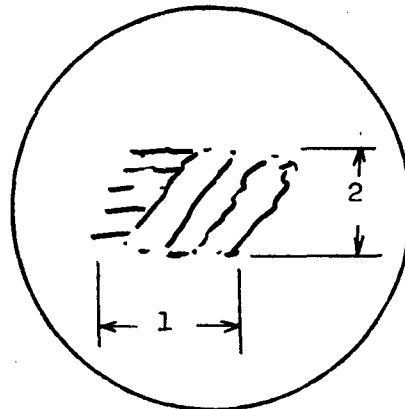
ROUND NUMBER T 11

The skin was completely destroyed. The backing board failed with a 4 in. x 6 in. cored section. The self-sealing material was also slightly cored and leaked at a reduced rate. Flange again let go so could not establish a rate.

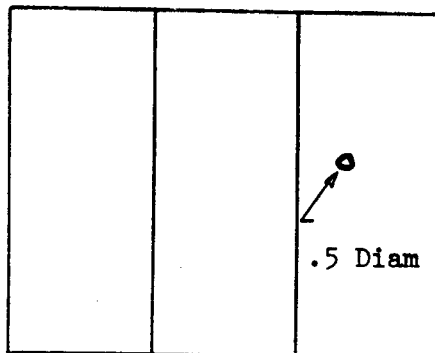
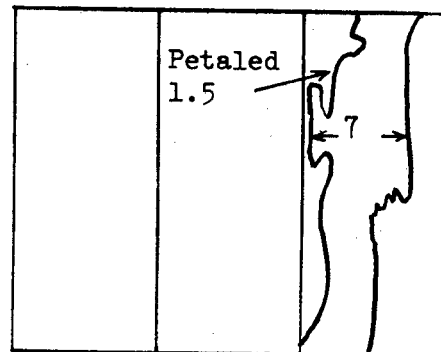
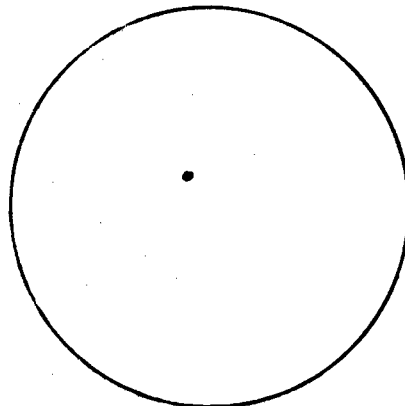
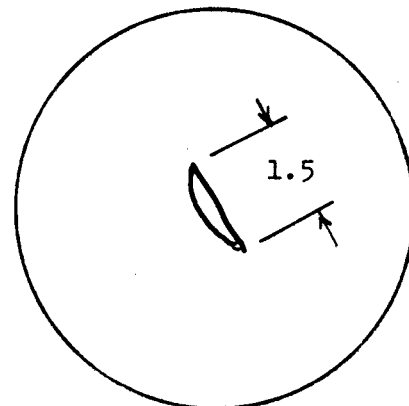
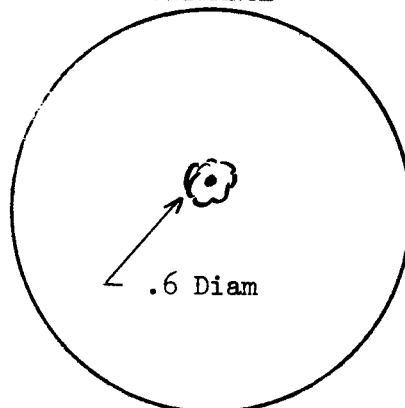
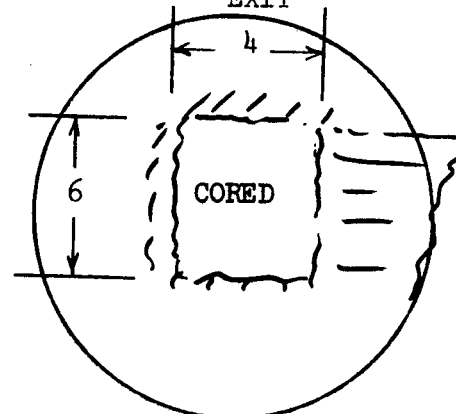
ROUND NUMBER T 12

The fuel tank was shot with the 2 inch vent cap off. Some fuel was splashed out of the vent when the tank was hit by the projectile. The projectile entrance was straight 12 inches below the fuel surface, and the exit was fully tumbled 9 inches below the fuel surface. The entrance skin was cored, the backing board just frayed with no trace of fuel leaking in the self-sealing material. The exit wound sealed with only a trace of fuel escaping. The exit skin was petaled to a height of 1.4 inches with no coring. The backing board was frayed. Observers noted a flash on the entrance of the projectile at the skin.

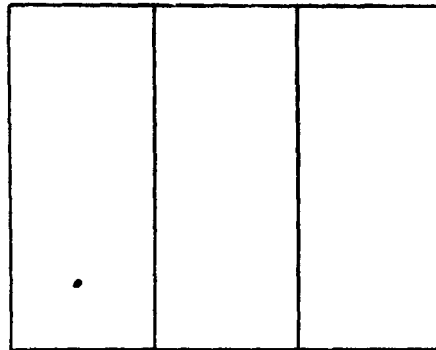
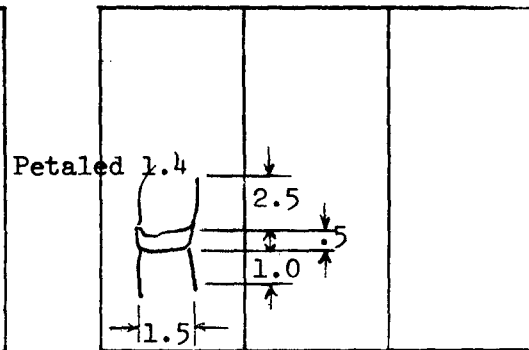
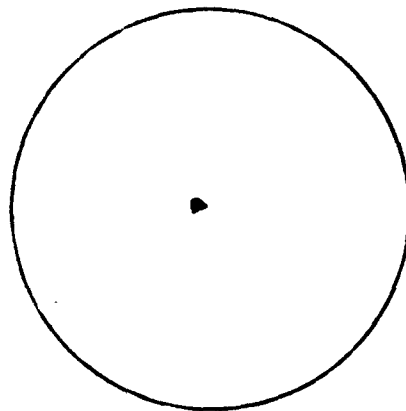
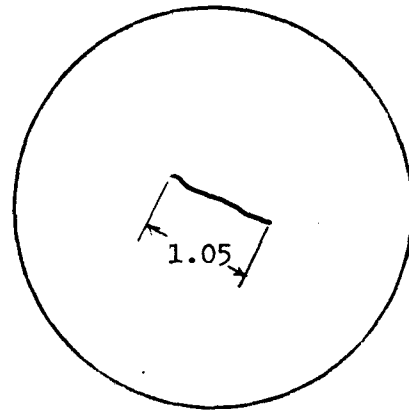
ROUND NUMBER T 13

Exit: No exit of projectile through skin, but leakage occurred. The backing board was slit and the self-sealing material was slit from the tumbled exit of the projectile. The wound leaked for 9 minutes until the pressure was reduced to zero. When repressurized the wound held its seal. Total leakage was 1.2 gallons in 9 minutes.

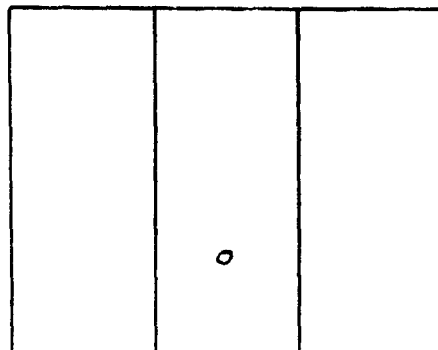
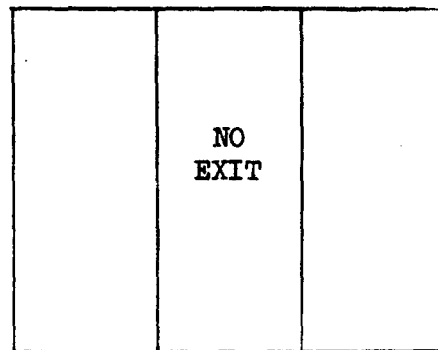
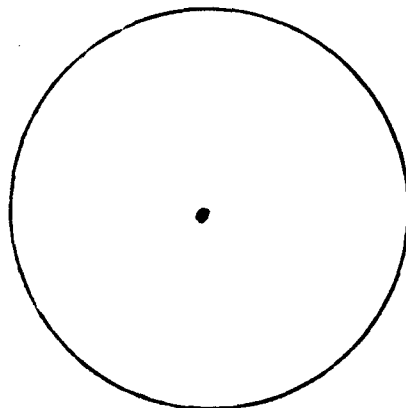
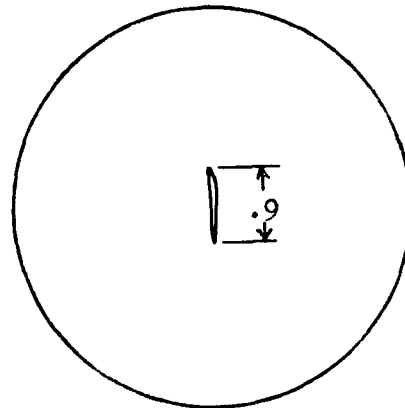
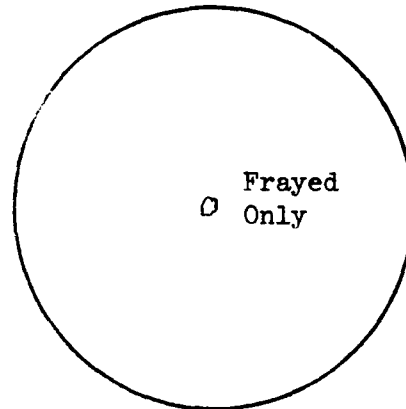
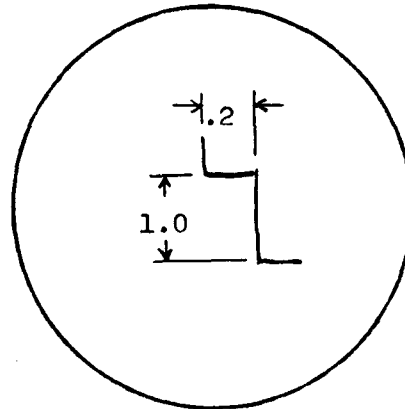
ROUND NUMBER T 14

Entrance: The projectile entered straight. The entrance metal was cored but no petaling existed and the backing board was frayed. The self-sealing material sealed. There was no trace of fuel leakage.

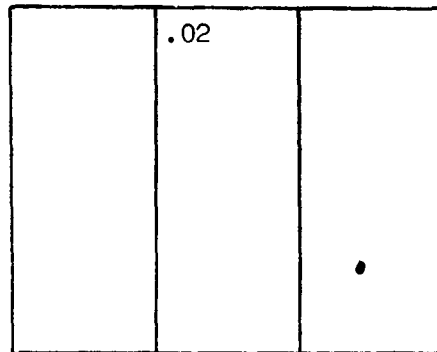
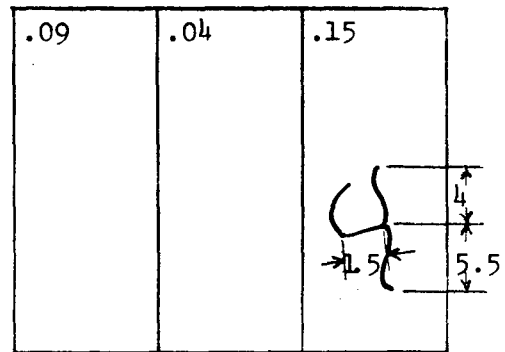
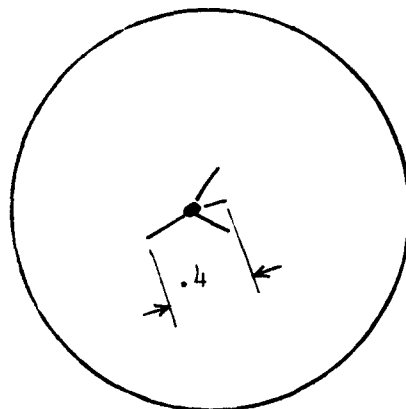
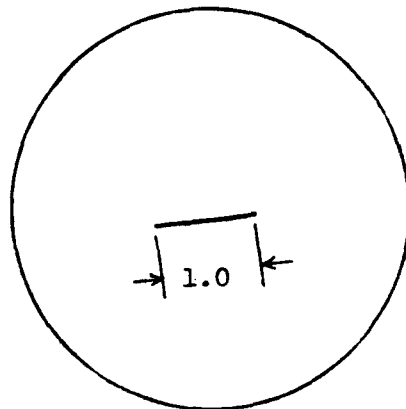
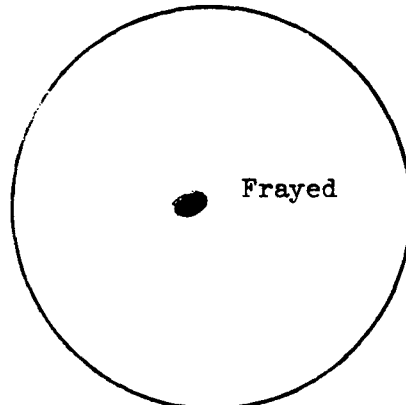
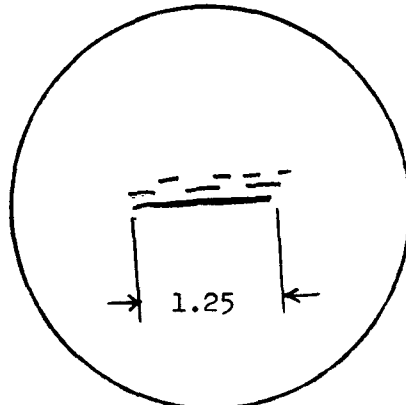
ROUND NUMBER T 15

1.5 inches below fuel surface. Skin was cored as was the backing board. The self-sealing material sealed damp immediately. No visible flow of fuel on wound was noted.

The projectile struck the exit side self-sealing material and just cracked it. No other damage was noted. A flash of fire was seen on the entrance skin.

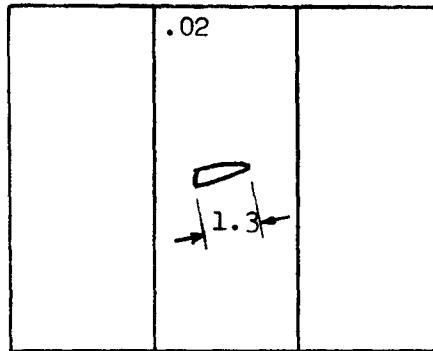
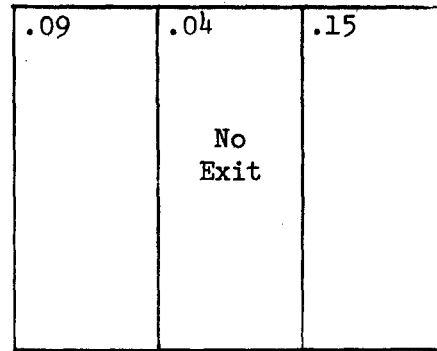
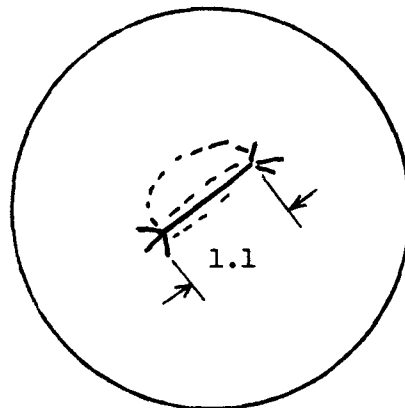
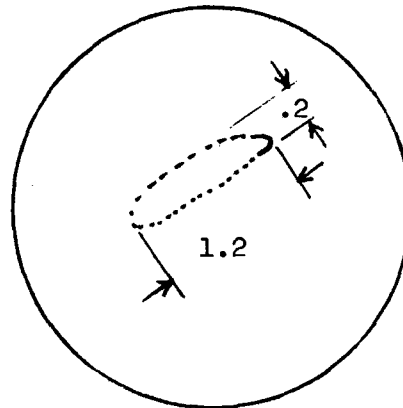
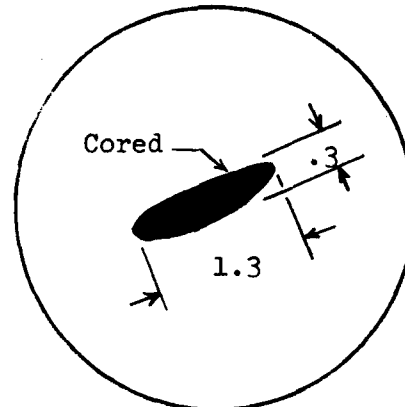
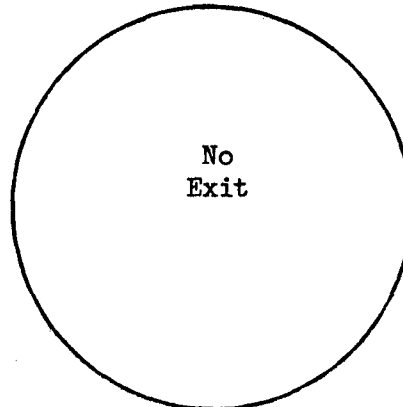
BLOCK NUMBER B 10  
 ROUND NUMBER T 16

Entrance 4 inches below fuel surface. The skin was cored. The backing board frayed and cored slightly. The self-sealing material was slit and had metal stuck in the wound. However, it sealed around the metal to a damp seal in 4 minutes and dry seal in 10 minutes. No leakage was great enough to measure.

The self-sealing material was partially split but not penetrated by the projectile. No Leakage occurred.

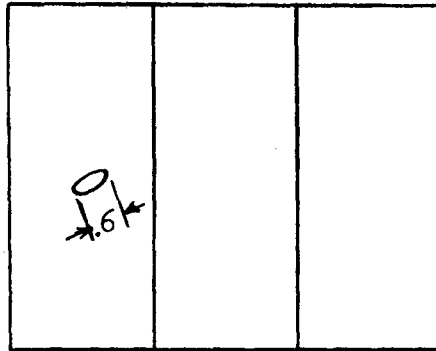
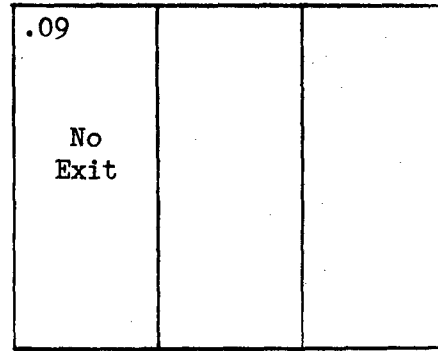
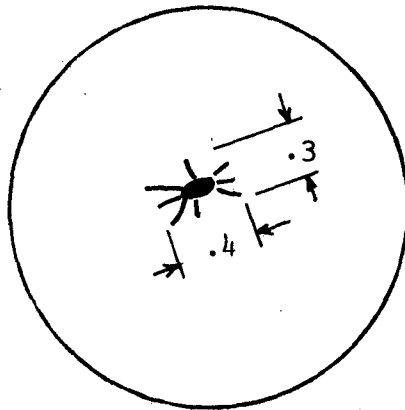
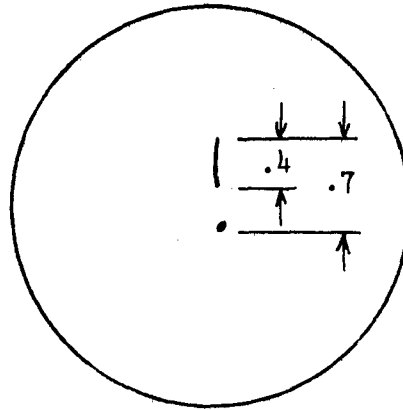
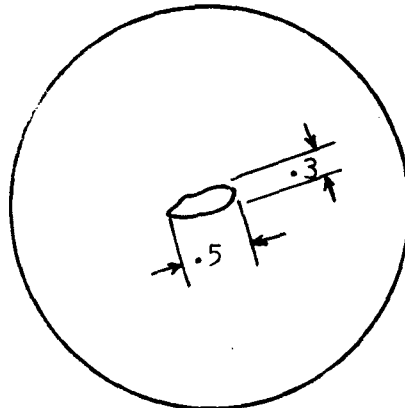
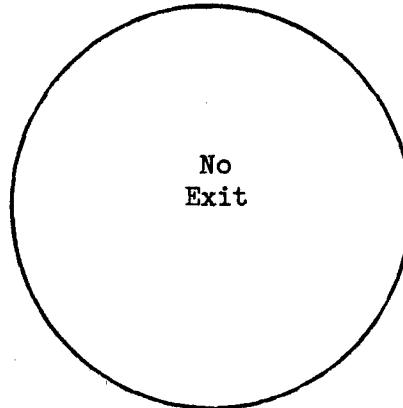
ROUND NUMBER T 17

Entrance 3.5 inches below the fuel surface. The skin was cored as was the backing board. No trace of any fuel leakage.

The projectile slit the back self-sealing material but did not damage the backing board or skin. No leakage.

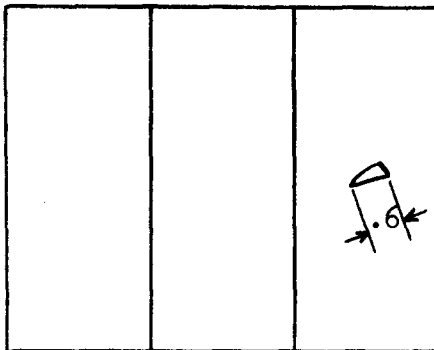
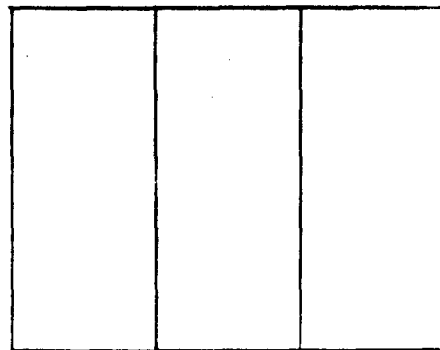
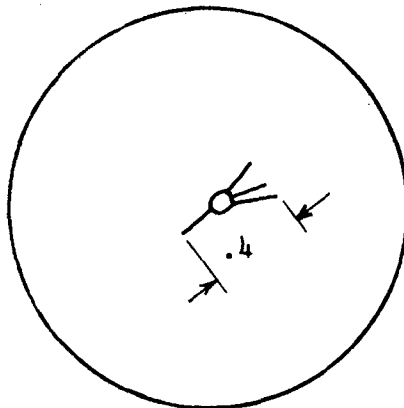
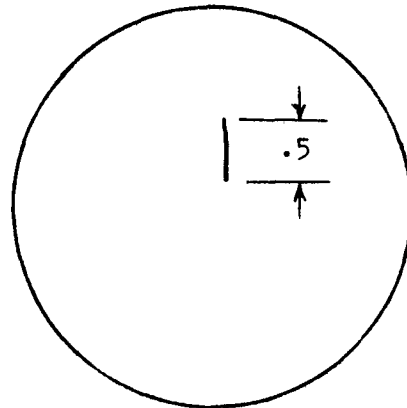
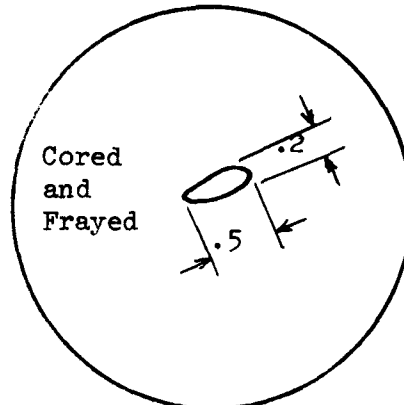
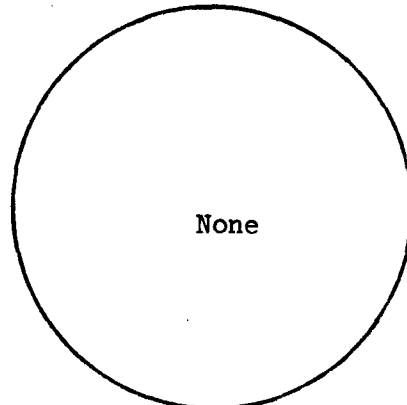
ROUND NUMBER T 18

Backing board frayed but there was no trace of leakage in the self sealing wound. Instant seal.

Nicked the wood support. The backing board frayed. The wound flowed fuel for 2 minutes then stalled to a drip. The wound would not seal any more and a constant leakage rate of 100 drops/minute was maintained. When given support the wound would seal to a damp seal with very slow dripping. Had to apply support to wound to continue shots. Did leak some when pressurized (200 drops/minute).
